HOUSES OF THE 1940s, 1950s,
AND 1960s ARE NOW OLD
ENOUGH TO SUFFER FROM THE
INDIGNITIES OF AGE AS WELL
AS CONSTANT ASSAULTS MADE
TO “UPDATE” THEM. APPLIED
THOUGHTFULLY, MODERN
MATERIALS AND METHODS WILL
MAKE THEM BETTER THAN NEW.

BY MARY ELLEN POLSON

Postwar

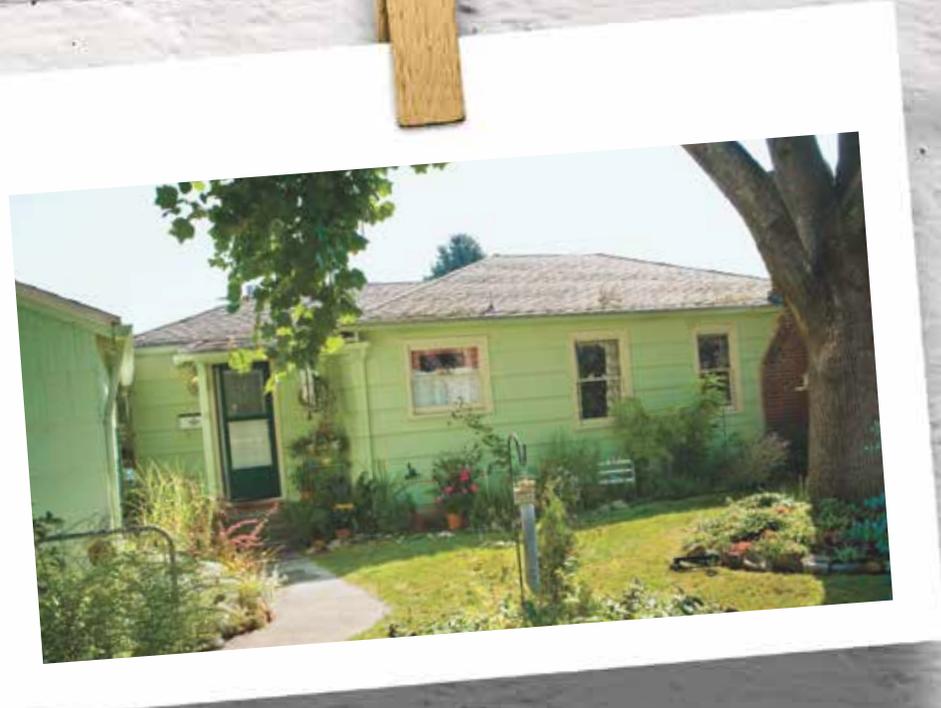
Mid-century houses range from an architecturally significant 1939 Frank Lloyd Wright design to a 1940s raised ranch and a simple suburban ranch with a shallow hipped roof, built in 1947.

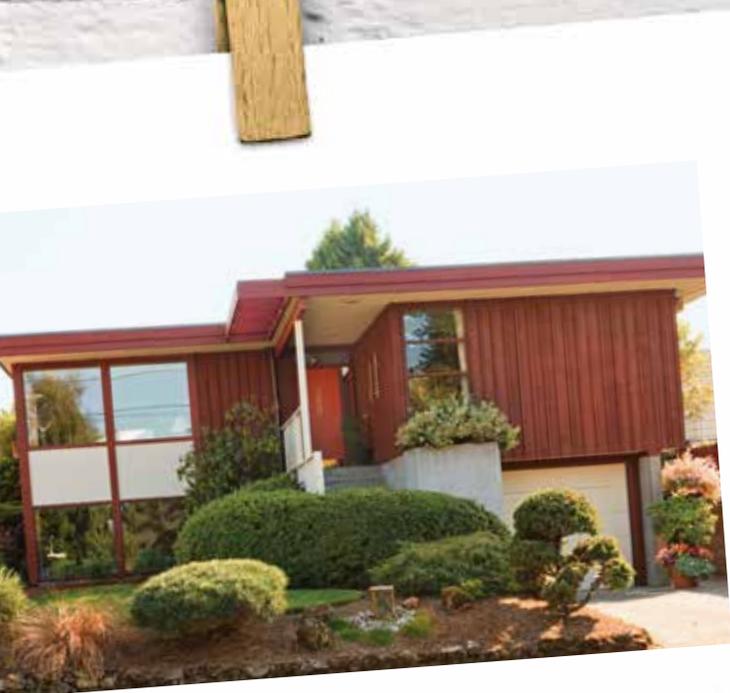
↑
A 1955 Usonian-influenced house with cedar board-and-batten siding and a nearly flat roof exhibits some of the attractions of mid-century architecture, from horizontal emphasis to oversized windows.

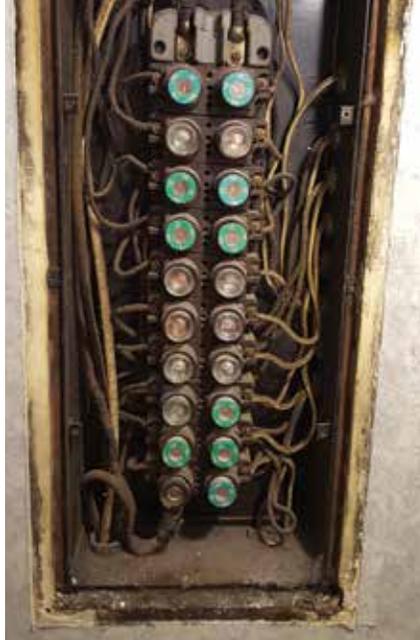
This old fuse box is loaded with obsolete wiring and it lacks adequate insulation.

The bad news is that most postwar houses didn't miss the fuse era. A common design for fuse boxes in homes built between 1940 and 1965 was the 60-ampere fuse box. (An ampere, or amp for short, is a unit of electric current.) Inside were four Edison-base plug fuses for branch circuits, and one or more fuse blocks for cartridge fuses to serve major appliances. Electrical junction boxes with 100-ampere or higher service appeared about 1985. Today, 200 amps is standard, but modern electrical needs are pushing even this higher standard, too.

While fuse panels are still legal in most places, having one in the house is usually an indicator that the wiring may be equally obsolete. Additionally, there is a risk of fire if, say, someone plugs a 20-ampere fuse in a slot for a 15-ampere fuse. The electrical wires can't handle the higher amperage, causing the wires to overheat. Once damaged, the danger remains even if the 20-ampere fuse is replaced with one of the correct size. *[text cont. on page 47]*

To fix it, the old circuit must be rewired. The modern standard is an electrical panel with circuit breakers, not fuses.

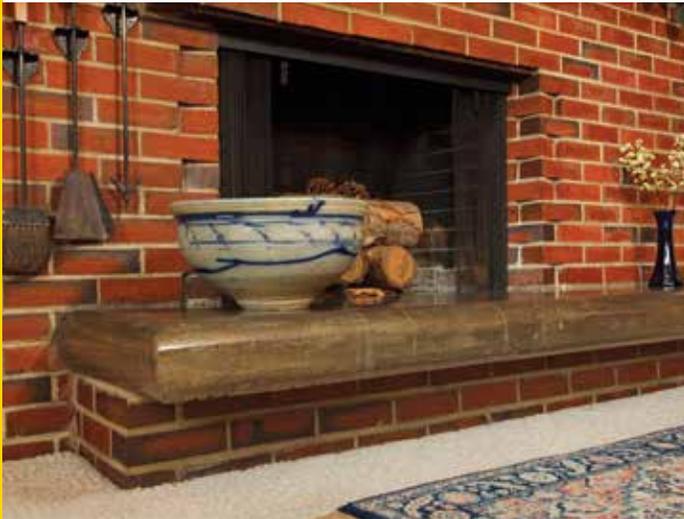
ABOVE Unadorned brick is a mid-century treasure to savor. Never paint it—you'll just create a labor-intensive job for some future restorer.

Avoid painting, removing, or altering original brick and stone walls, planters, and fireplaces. Removing paint from brick or stone is a labor-intensive process involving heat, chemicals, or both. Covering either with "updated" materials like stone veneer or tile can irreparably damage the surface, too.

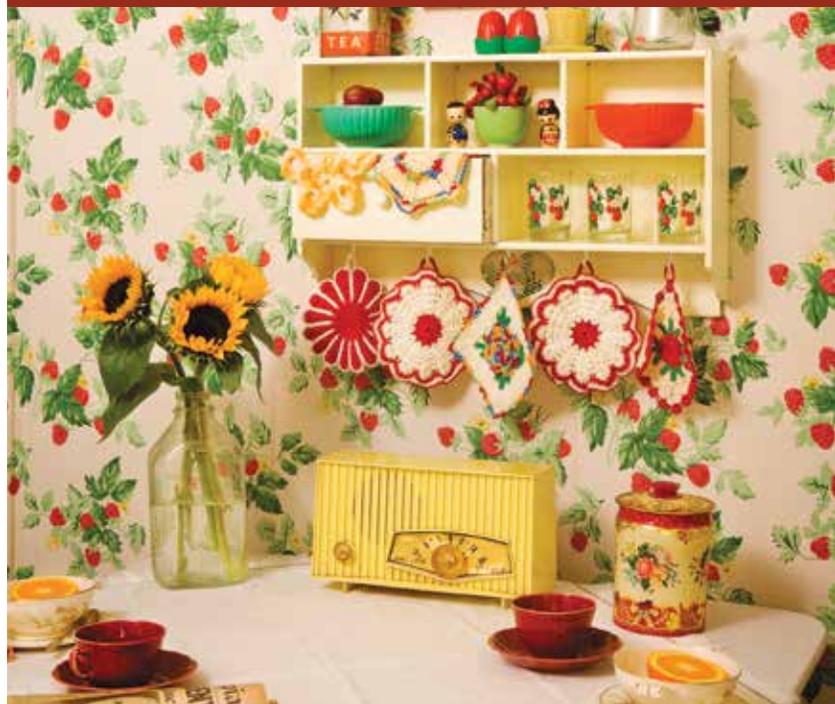
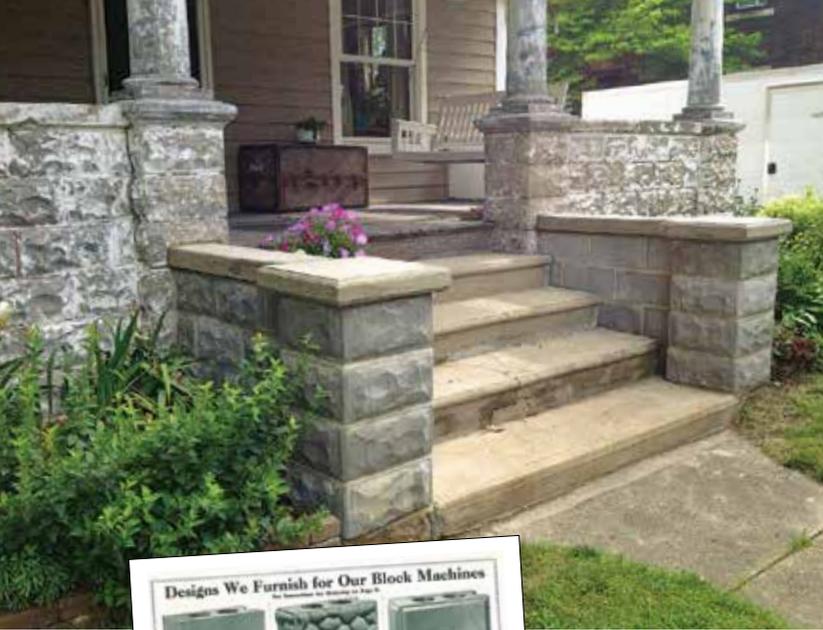
ABOVE Reproductions of early 20th-century rock-face block designs are available for repair or new-builds, from Classic Rock Face Block. **LEFT** Original patterns for rusticated brick, sold through a ca.1908 Sears, Roebuck catalog.

A standard for foundations and later as a substructure under brick or other forms of cladding, concrete block is one of the most ubiquitous 20th-century building materials. An early form was the handmade picturesque rusticated concrete block. So called because the exposed surface resembled textured stone, rock-face block first appeared late in the 19th century, when innovations in cement making made it possible to press concrete blocks on work sites. When an inventor named Harmon S. Palmer created a machine that added textured or architectural faces to the blocks as they were pressed, rock-face block became a national phenomenon. The blocks were a staple of Sears kit homes, appearing from the foundation to the roof line.

Many of these early concrete installations suffer from deterioration, especially steps, porch walls, and other exposed areas. Luckily, there are several sources for modern rusticated block. Classic Rock Face Block, for instance, offers reproductions in 29 original patterns, including multiple “rock” designs—from shallow to heavy rock—and architectural designs like the beveled-edge panel, a face that creates crisp architectural lines.

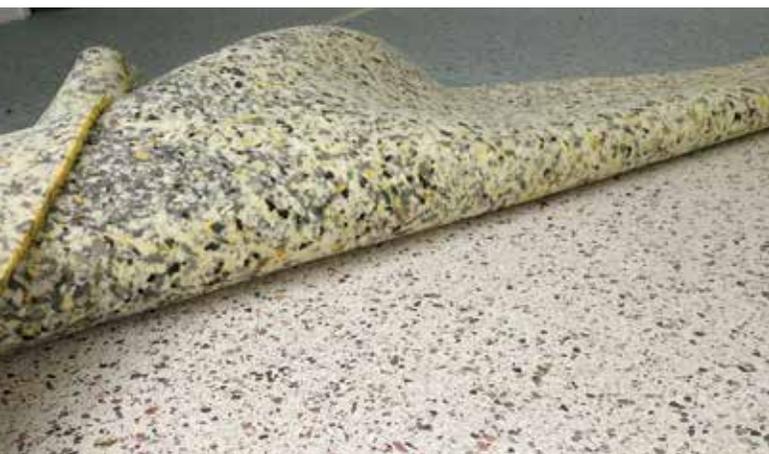
LEFT In many Sun Belt states, cool terrazzo floors could be hiding beneath old wall-to-wall.

during the 1960s. Terrazzo is a blend of aggregate—stone or marble chips—embedded in cast or poured concrete or cement. Once installed, terrazzo can last for decades with proper care.

Terrazzo is traditionally composed of two parts aggregate to one part Portland cement, bound together with just enough water to bring

the mixture to a cookie-dough consistency. Once leveled in place, additional stone chips are sprinkled over the surface to create a uniform appearance (min. 70% aggregate).

Terrazzo is subject to a variety of perils, from subsidence and earthquake damage to yellowing, stains, glue, minor cracks, and carpet-tack holes. Provided the floor isn't structurally compromised, it can be brought back to its original luster with a good machine polishing and buffing, which will remove the old sealer and any paint or glue. It's essential to find a contractor with experience in polishing—not

Minor holes can be filled with new terrazzo, or with epoxy that matches the base color of the terrazzo, followed by faux painting to mimic the aggregate. Larger cracks tend to occur around the metal divider stripes in period installations. They can be patched, but it isn't cheap. Luckily terrazzo colors have been standardized since 1931, so it should be possible to get a close match.

As a final touch, the surface should be sealed with a commercial penetrating sealer formulated specifically for terrazzo. Always use a neutral cleaner with a pH between 7 and 10.

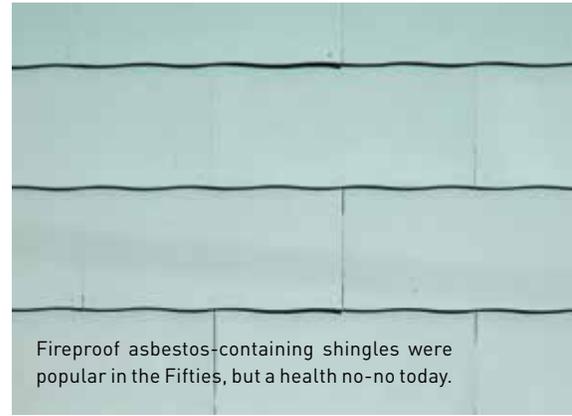
Fireproof asbestos-containing shingles were popular in the Fifties, but a health no-no today.

Speaking of asbestos, the material was rife in building products in the postwar years thanks to its fireproof properties. The good news: asbestos is only dangerous when it's deteriorating or disturbed. The bad news: when an asbestos-containing material is damaged, it releases microscopic fibers into the air, where they can be inhaled or swallowed. Exposure can cause lung cancer and a rare variant, mesothelioma.

The best approach to dealing with materials that may contain asbestos is to leave them alone if you can. That said, many banks will not write mortgages on houses that are known to contain asbestos, especially if it's wrapped around heating or cooling ducts. If you are planning a renovation that may disturb an asbestos-containing material, such as old siding or vinyl composite tile, have it tested by an accredited asbestos inspector. If asbestos is confirmed, the material should be removed only by a certified remediator. Removal is regulated at the state level: look for a licensed pro on your state government's website.
